RE: Request for Information (RFI) Pursuant to Section 308 of the Clean Water Act
Currie Valley Dairy, LLC Concentrated Animal Feeding Operation (NYA000328)
Docket No. CWA-IR-14-018

CAFO COMPLIANCE INSPECTION REPORT

Inspection Date: April 23, 2014	Inspector: Kimberly McEathron, Physical Scientist, USEPA, Region 2, (212) 637-4228
Inspection Time: 8:00 AM – 12:00 PM	
Inspection Type: Compliance Evaluation Inspection	
On-Site Representatives: John Currie, Owner, Currie Valley Dairy, LLC, (315) 696-8051; Colleen Currie, Co-owner, Currie Valley Dairy, LLC, (315) 696-8051; and Paul Murphy, CAFO Planner, Farm Compliance Services, (315) 427-4947	
Other Attendees: Stacy Russell, Cortland County Soil and Water Conservation District, (607) 597-9360; Scott Cook, NYSDEC Region 7, (315) 426-7502; and Julie Melancon, NYSDEC Region 7, (315) 426-7418	
Site Information:	Currie Valley Dairy, LLC 2267 Currie Road Tully, New York 13159 NPDES/ICIS No. NYA000328
SIC Code:	0241, Dairy Farms
Attachments:	EPA Form 3560-3 and New York State Department of Environmental Conservation, Division of Water, <u>CAFO Facility Inspection Report</u> , Version 1.0 – 3/15/06

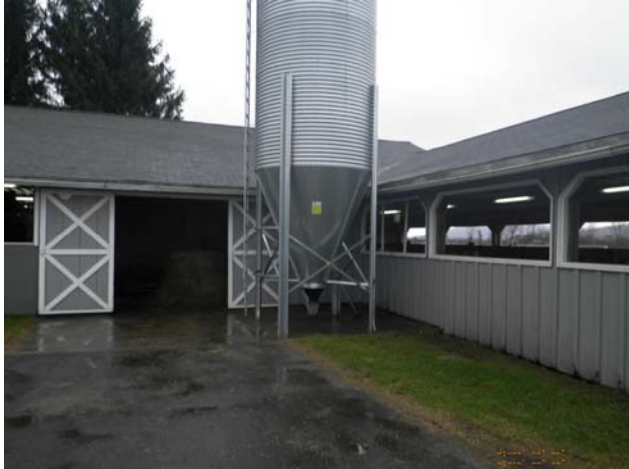
RIMG0054.JPG - Unmapped feed grain bin located on north side of Holstein Barn at the Holstein Facility (view facing southeast)

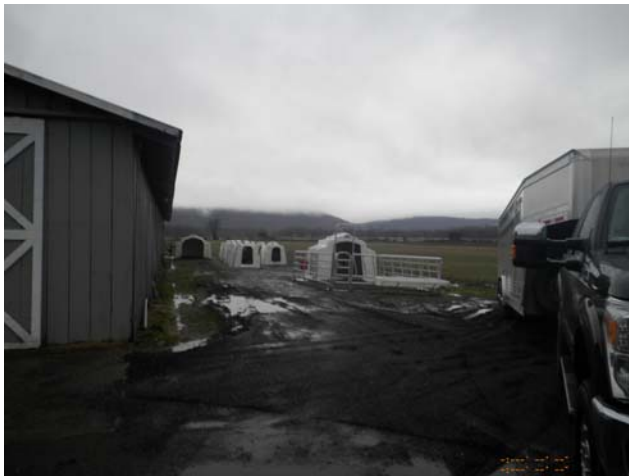
RIMG0055.JPG – Calf hutches on the north side of the Commodity Storage Barn at the Holstein Facility (view facing west)

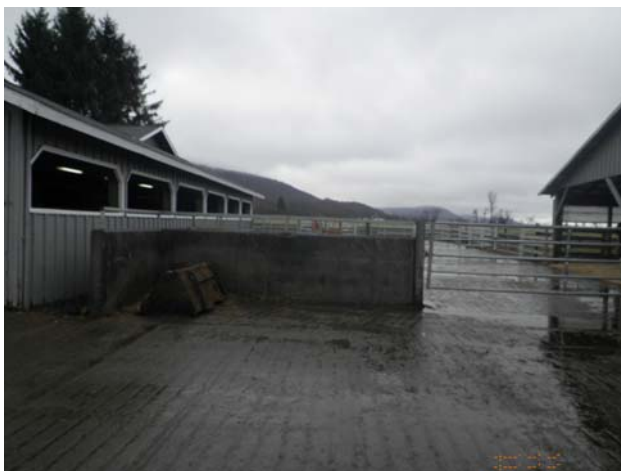
RIMG0056.JPG – Concrete stacking pad between the Dry Cow and Holstein Barns at the Holstein Facility (view facing south)

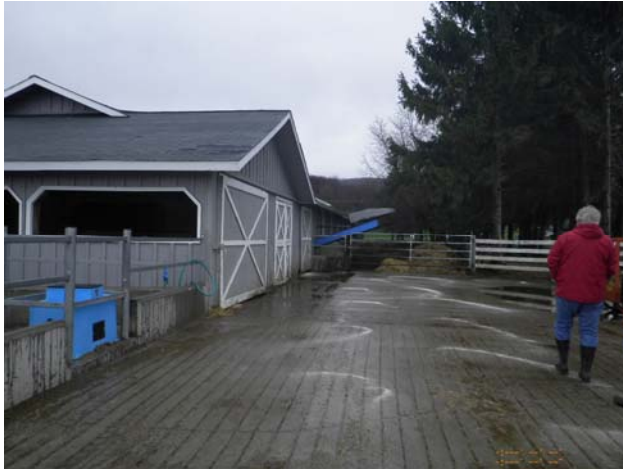
RIMG0057.JPG – Manure loading area along the south side of the Holstein Barn at the Holstein Facility (view facing east)

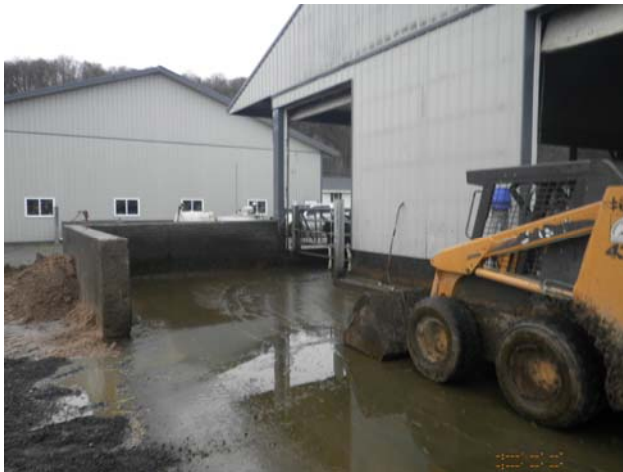
RIMG0067.JPG – Daily spread loading area on the north side of Heifer Barn at the Main Facility (view facing south)

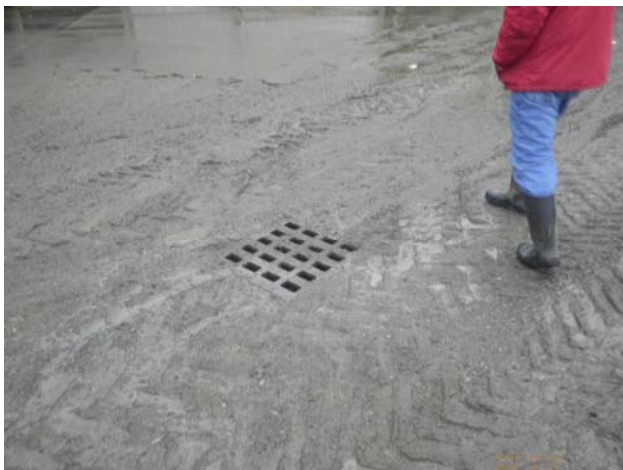
RIMG0071.JPG - 1st unmapped storm drain south of the Calf Transition Barn at the Main Facility (view facing southwest)

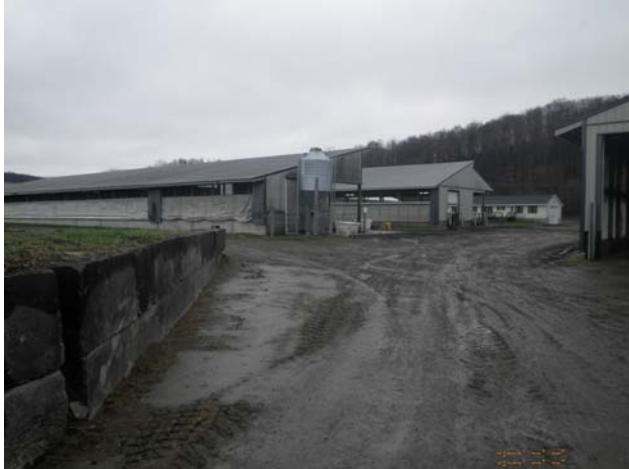
RIMG0072.JPG - Unmapped feed grain bin south of the Calf Transition Barn at the Main Facility (view facing northeast)

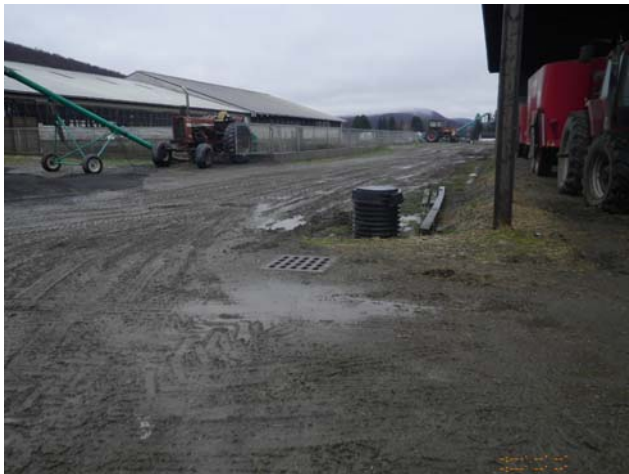
RIMG0073.JPG - 2nd unmapped storm drain northwest of the Concrete Manure Storage and adjacent to the Hay Storage at the Main Facility (view facing south)

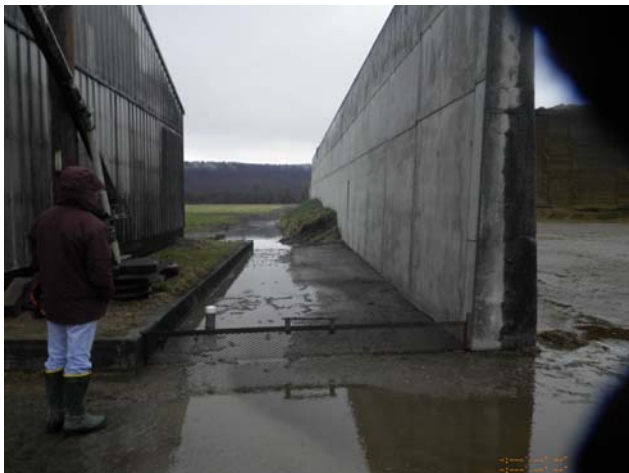
RIMG0075.JPG - Silage leachate collection system south of Bunk Silo, level lip spreader under pooling liquids (view facing west)

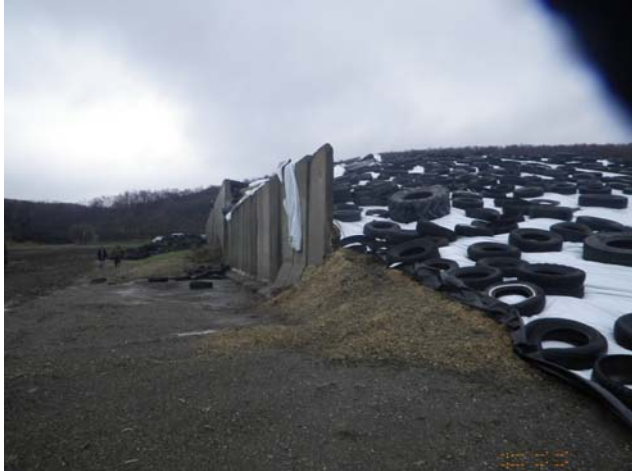
- b. Silage was observed along the north side of the Bunk Silo extending beyond the concrete walls and exposed to stormwater (see photograph RIMG0079.JPG);

RIMG0079.JPG - Bunk silo contents exposed on northwest corner at the Main Facility (view facing east)

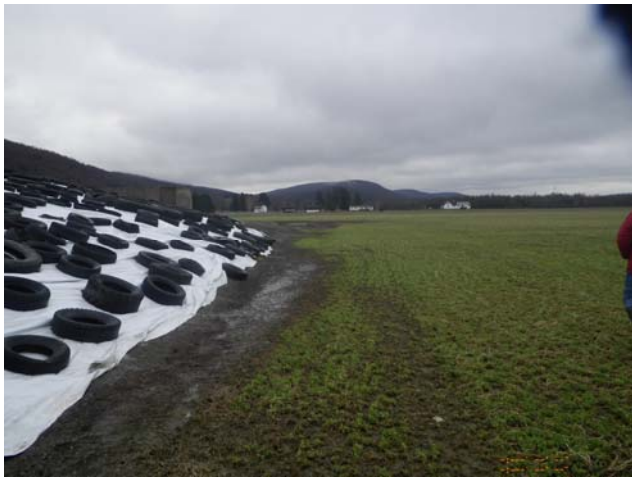
RIMG0080.JPG – West end of Bunk Silo at the Main Facility (view facing south)

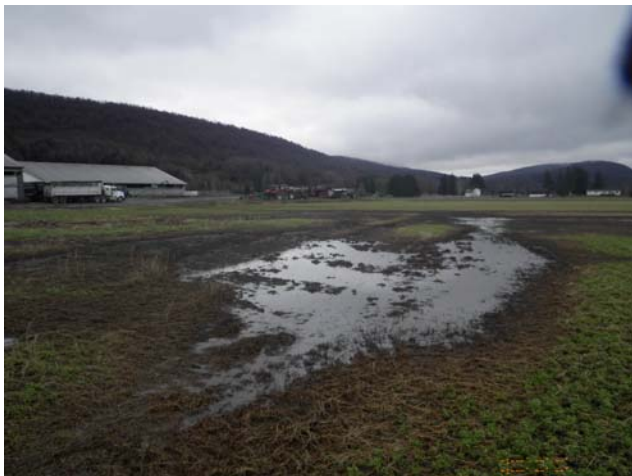
RIMG0081.JPG - Liquids pooling in VTA at the Main Facility (view facing south)

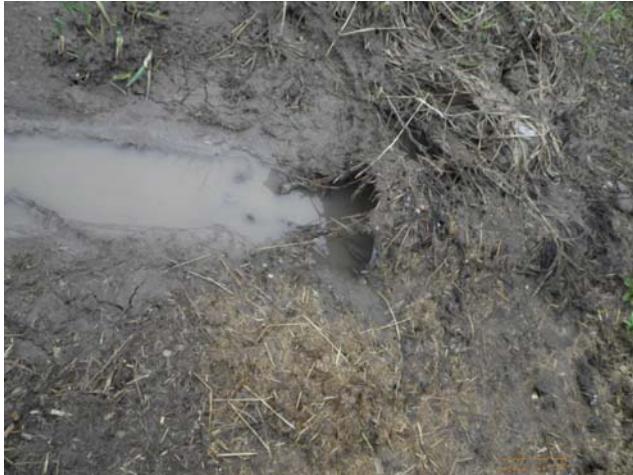
RIMG0083.JPG - Clean water diversion pipe discharging to VTA at the Main Facility (view facing north)

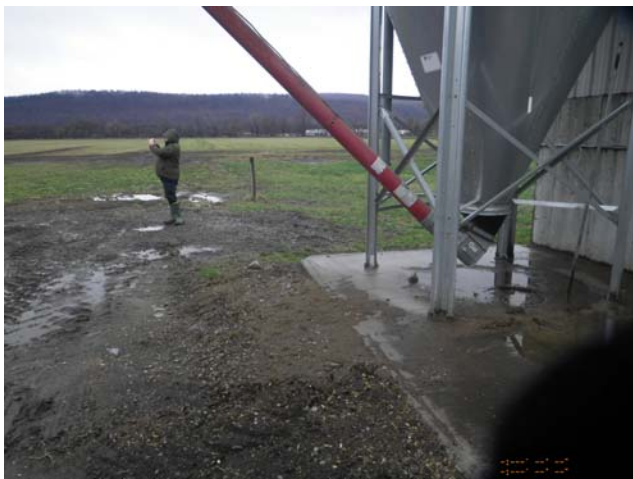
RIMG0084.JPG - Unmapped feed grain bin with feed on the ground uphill from clean water outfall at the Main Facility (view facing west)

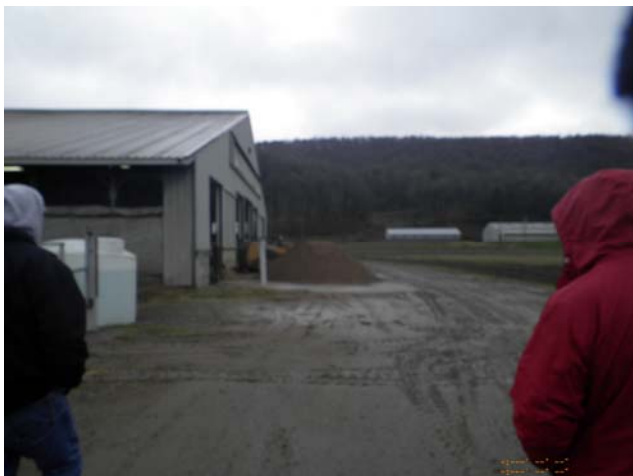
RIMG0087.JPG – Sand bedding pile at the south end of the Freestall Milking Barn #1 at the Main Facility (view facing east)

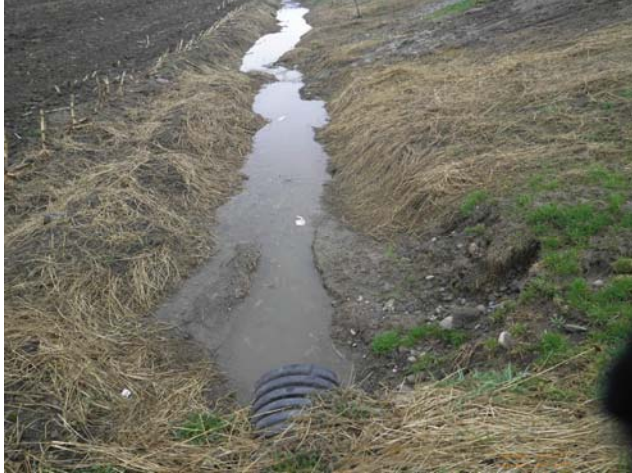
RIMG0089.JPG - Drainage ditch and pipe south of Main Facility (view facing west)

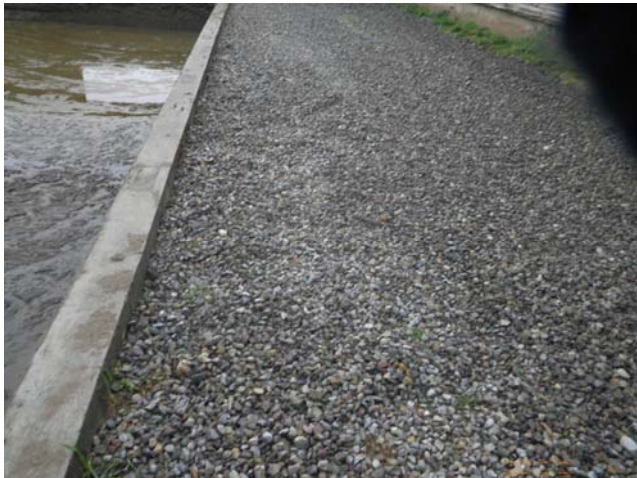
RIMG0092.JPG - Close up of manure over gravel drip trench drains east of reception pit at the Main Facility (view facing north)

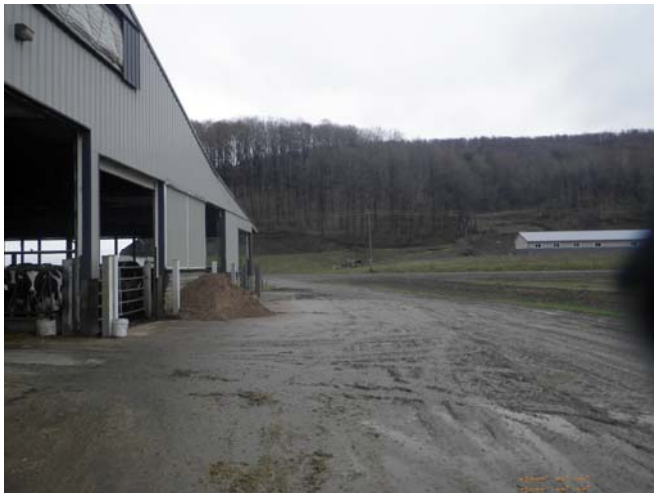
RIMG0093.JPG – Sand bedding pile south of Freestall Milking Barn #2 at the Main Facility (view facing east)

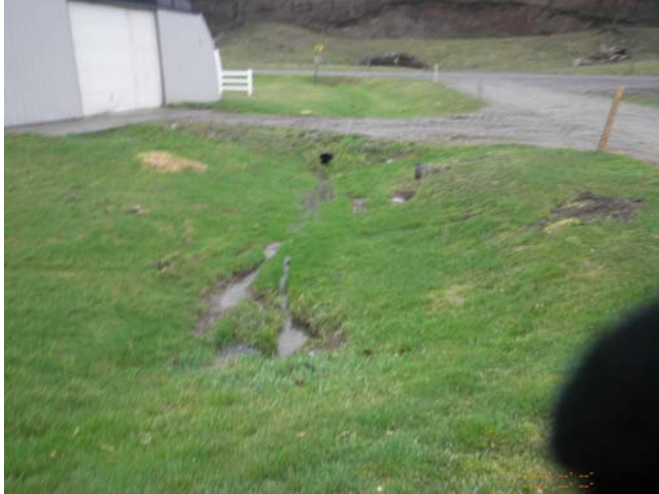
RIMG0094.JPG - Unmapped clean water diversion ditch and culvert south of Calf Barn at the Main Facility (view facing east)

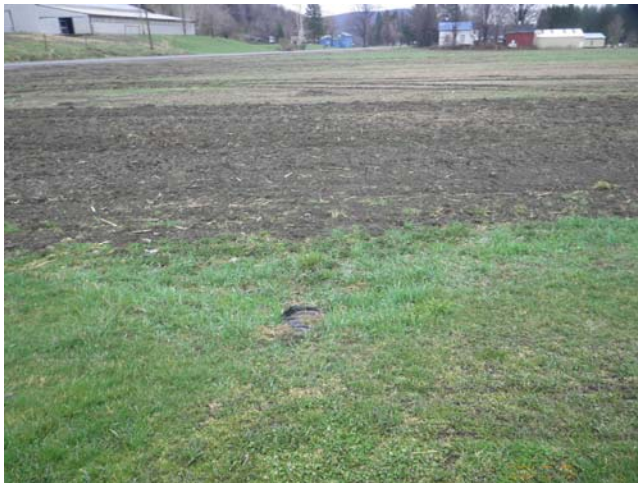
RIMG0095.JPG - Unmapped clean water diversion ditch pipe south of Calf Barn to adjacent field at the Main Facility (view facing south)

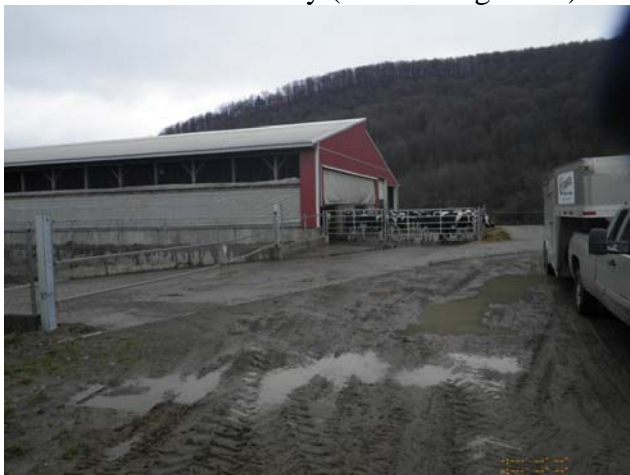
RIMG0097.JPG – Feed and manure exposed to stormwater at the south end of the Dry Freestall Barn at the Heifer/Slab City Facility (view facing east)

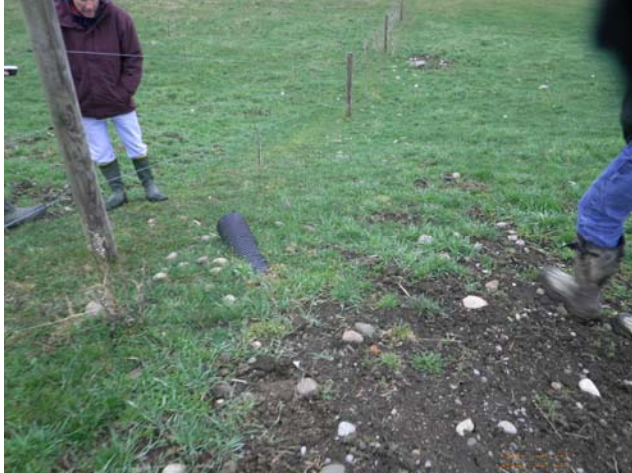
RIMG0101.JPG – Unmapped clean water pipe to pasture at the Slab City Facility (view facing east)

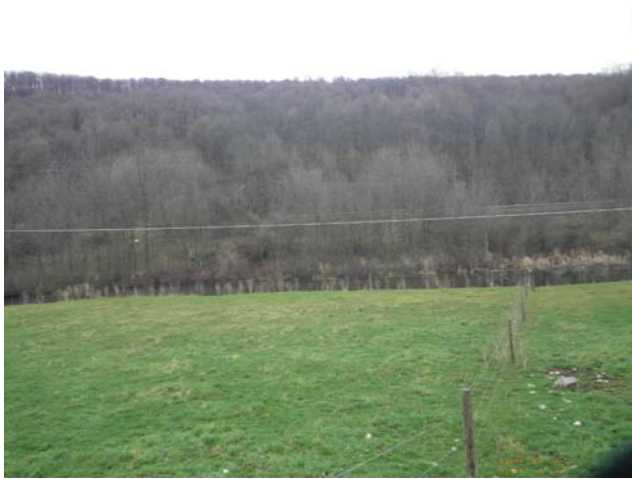
RIMG0104.JPG – Fenced vegetated pasture along West Branch of the Tioughnioga River at the Slab City Facility (view facing east)

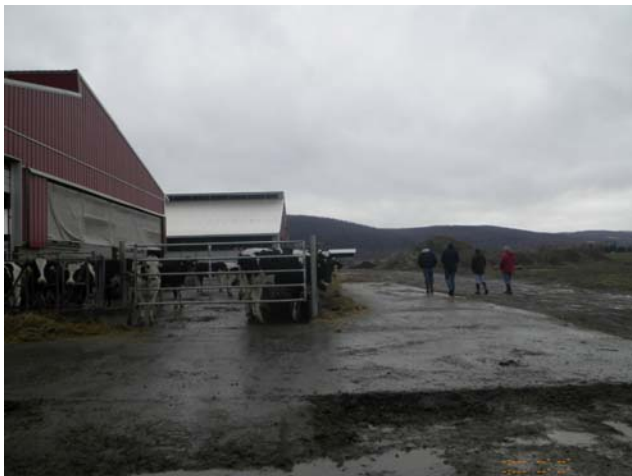
RIMG0107.JPG – North end of the Freestall Barns at the Heifer Facility/Slab City (view facing west)

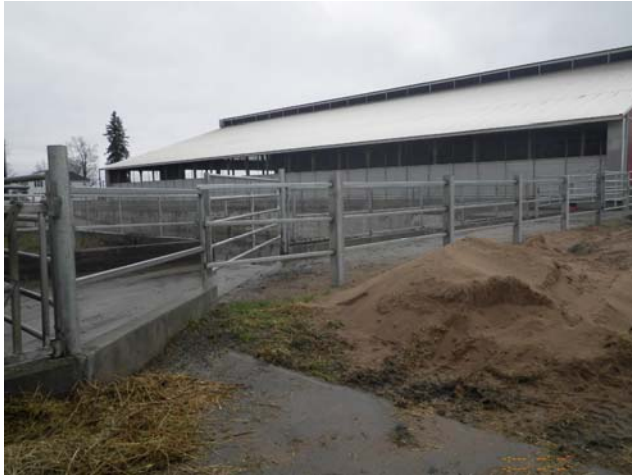
- i. Sand bedding piles at the Slab City/Heifer Facility along the north end of the manure storage structure (see photograph RIMG0108.JPG).
3. The CNMP recommended no manure applications for Field 79 for crop year 2013, however, on March 4, 2013 1,500 gallons per acre of liquid manure and six (6) tons per acre of pack manure was applied. Field 79 is 10.9 acres and is located adjacent to a tributary to the West Branch of the Tioughnioga River and has a low Phosphorus Index score at 6. According to Facility representatives, Field 79 was a new grass field and manure applications in 2013 are considered when developing recommendations for crop year 2014. Field 52 was not on the manure application recommendation list in the CNMP for crop year 2013, however, 1,500 gallons per acre was applied to the field in July 2013. Field 52 is 39.5 acres and is located adjacent to the West Branch of the Tioughnioga River. According to Facility representatives, Field 52 was combined with Field 53 and labeled as Field 51 but had been split up.

RIMG0108.JPG – Sand bedding piles at the north end of the manure storage at the Heifer Facility/Slab City (view facing southwest)

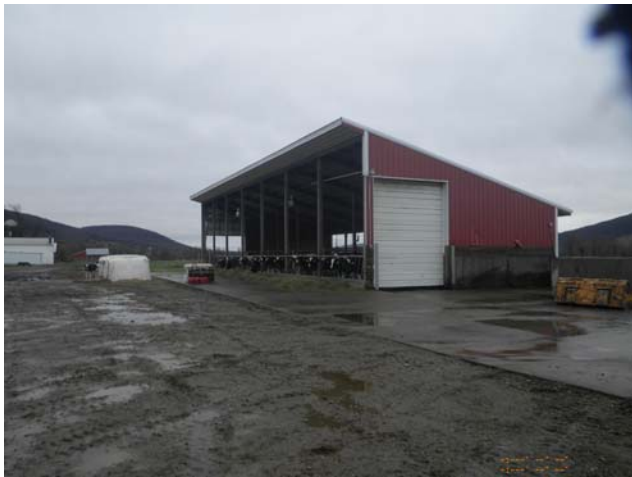
RIMG0110.JPG – Calf hutches at the Heifer Facility/Slab City (view facing southwest)

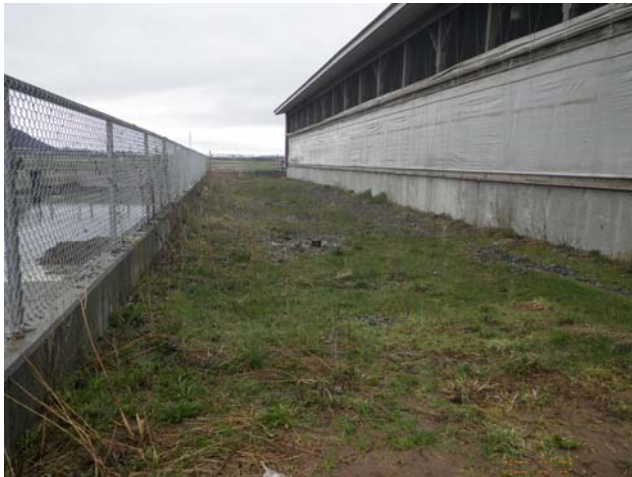
RIMG0111.JPG - Unmapped clean water pipe drain between manure storage and Freestall Barn at the Slab City Facility (view facing north)
